Manhole Inspection Summary

Manhole # S39E2_016MH

Insp Date: **4/1/08 11:48 AM**

Location Address: **500 Townsend Ave.**

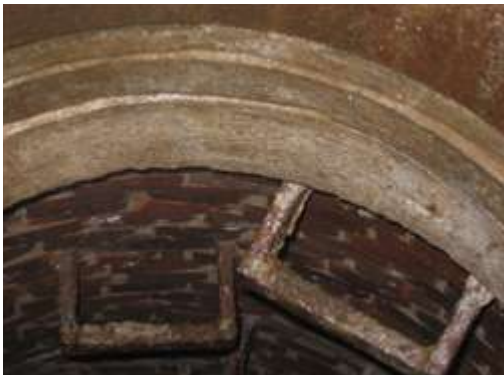
Top View

Steps Count: **4** Missing: **0** ☒ **Corroded**

steps

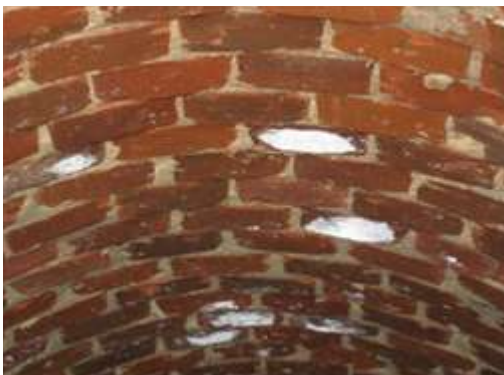
Defect 2

Infiltration: ☐ None ☐ Joint ☐ Cracks ☐ Mortar ☐ Roots ☒ **Wall**

Infiltration

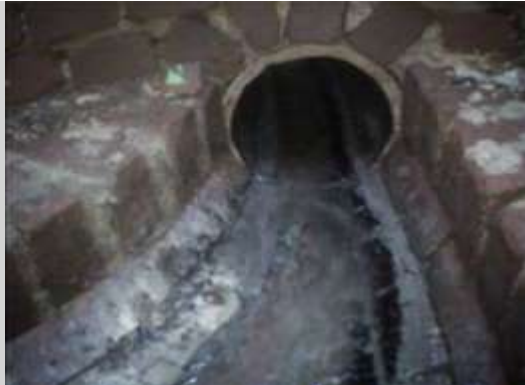
12 O'Clock Outflow

8 in. Circular Gravity Sewer
Pipe Out @ 12 O'Clock

Pipe Height: **9.6** (in.) Rod and Bar (Angled)
Pipe Material: **Clay** ☐ Pipe Lined
Invert Depth: **9.47** (ft.) Flow Characteristics: **Fast**
Deposits: ☒ None ☐ Mud ☐ Sludge ☐ Debris ☐ Grease
Silt Depth: (in.) Deposits Extent:
Infiltration: **None** Pipe Seal Cond: **Sound**

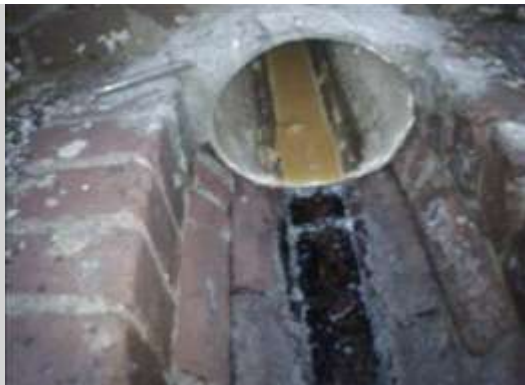
6 O'Clock Inflow

10 in. Circular Gravity Sewer
Pipe In @ 6 O'Clock

Pipe Height: **9.6** (in.) Rod and Bar (Angled)
Pipe Material: **PVC** ☐ Pipe Lined
Invert Depth: **9.36** (ft.) Flow Characteristics: **Fast**
Deposits: ☒ None ☐ Mud ☐ Sludge ☐ Debris ☐ Grease
Silt Depth: (in.) Deposits Extent:
Infiltration: **None** Pipe Seal Cond: **Sound**

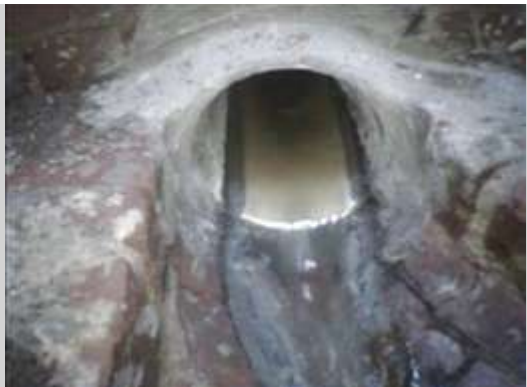
9 O'Clock Inflow

10 in. Circular Service Sewer
Pipe In @ 9 O'Clock

Pipe Height: **9.6** (in.) Rod and Bar (Angled)
Pipe Material: **Clay** ☐ Pipe Lined
Invert Depth: **9.35** (ft.) Flow Characteristics: **Fast**
Deposits: ☒ None ☐ Mud ☐ Sludge ☐ Debris ☐ Grease
Silt Depth: (in.) Deposits Extent:
Infiltration: **None** Pipe Seal Cond: **Sound**
